**IRRIGATION AND FLOOD PROTECTION REHABILITATION PROJECT**  
**ADB LOAN No. 1259 - VIE (SF)**

**SUMMARY**  
**of**  
**BENEFIT MONITORING AND EVALUATION**  
**FINAL REVIEW REPORT**

Prepared by:  
Consortium EXPERCO/KCC/ECI

April 2001

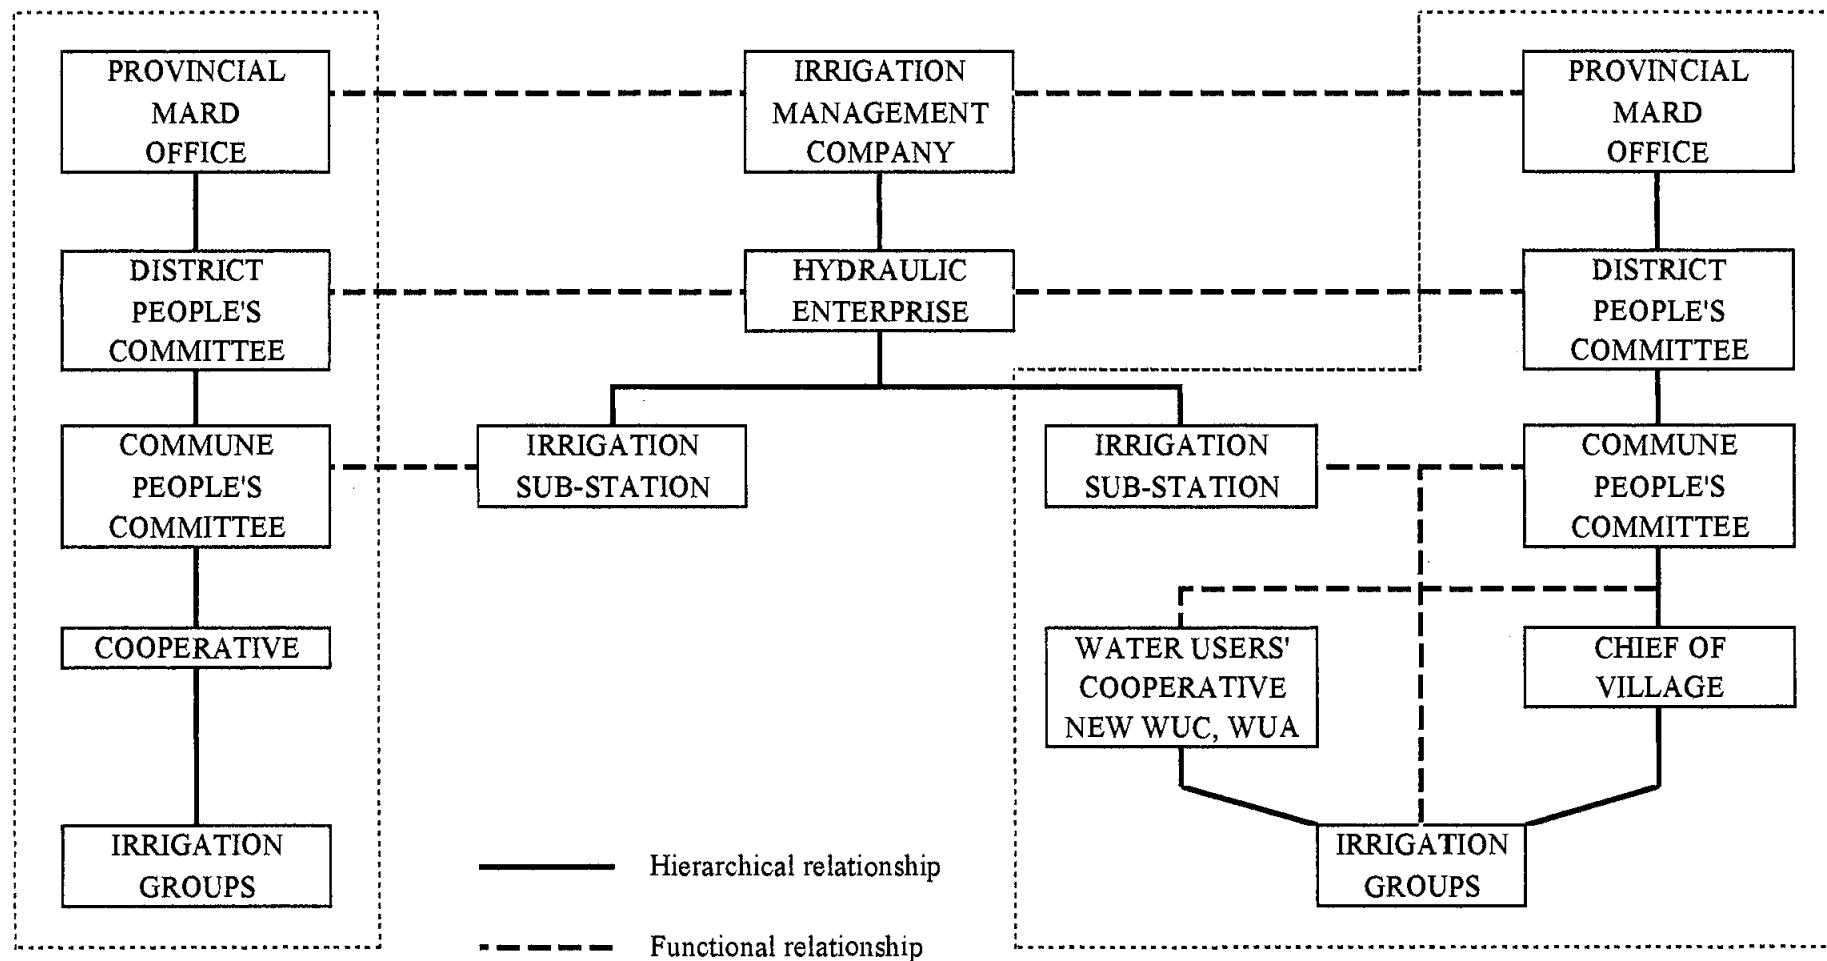
1995 MODEL

2000 MODEL

A diagram showing the O&M relationships and the changes between 1995 and 2000 is shown on Figure 3.2. In this summary, description is limited to broad categories with an emphasis on the changes, which have taken place. For a more complete description of the organisation, reference should be made to Section 4.5 of the main report.
